A GIS based study on bank erosion by the river Brahmaputra around Kaziranga National Park, Assam, India

J. N. Sarma and S. Acharjee

Department of Applied Geology, Dibrugarh University, Dibrugarh, 786004, India

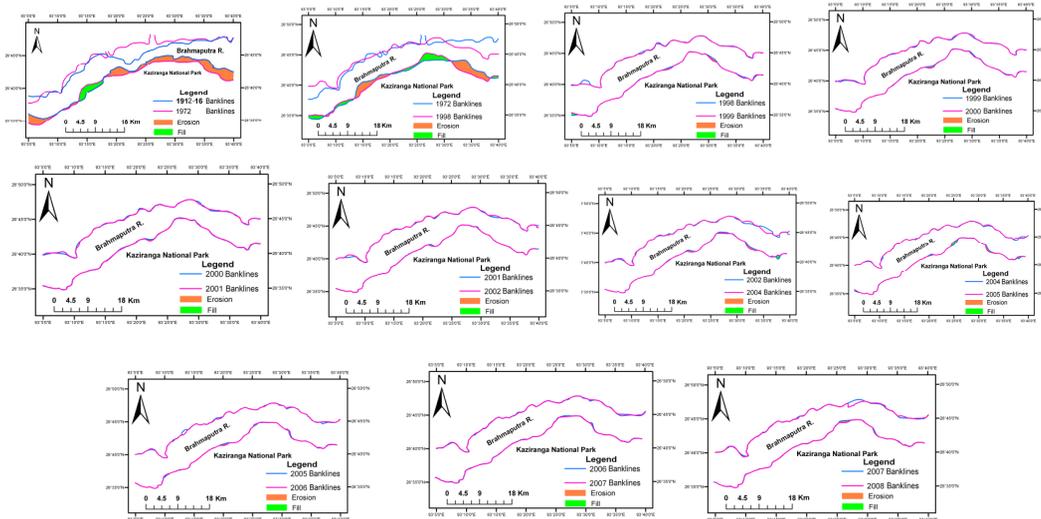
Fig. 2. Erosion and fill-ups of Brahmaputra River form 1912 to 1972, 1972 to 1998, 1998 to 1999, 1999 to 2000, 2000 to 2001, 2001 to 2002, 2002 to 2004, 2004 to 2005, 2005 to 2006, 2006 to 2007 and 2007 to 2008.

As mentioned earlier the Kaziranga National Park is undergoing heavy loss of land, in particular, on east-north eastern and western sides. Erosion and fill-ups of Brahmaputra River from 1912–1916 to 1972, 1972 to 1998, 1998 to 1999, 1999 to 2000, 2000 to 2001, 2001 to 2002, 2002 to 2004, 2004 to 2006, 2006 to 2007 and 2007 to 2008 are shown diagrammatically in Fig. 2. The area lost due to erosion and gained by fill up of

the earlier channel are found out using Erdas software from the maps given in Fig. 2 and presented in Table 1.

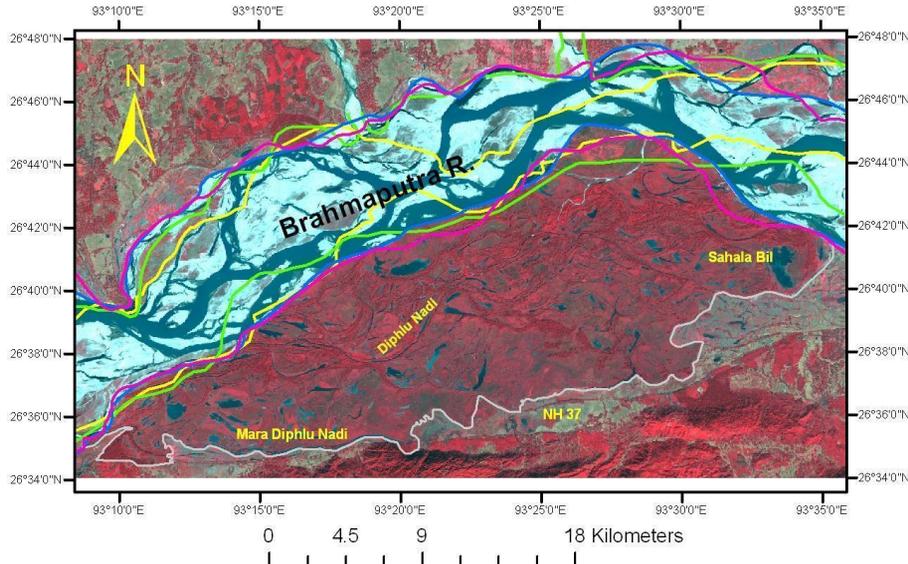
**Fig. 3.** Blankline changes along Kaziranga National Park in different years.

The positions of south bank of the Brahmaputra along Kaziranga park for the years 1912–1916, 1972, 1998 and 2008 are shown in Fig. 3 to give an idea of bankline migration. It is evident from the figure that the bankline was never stationary.

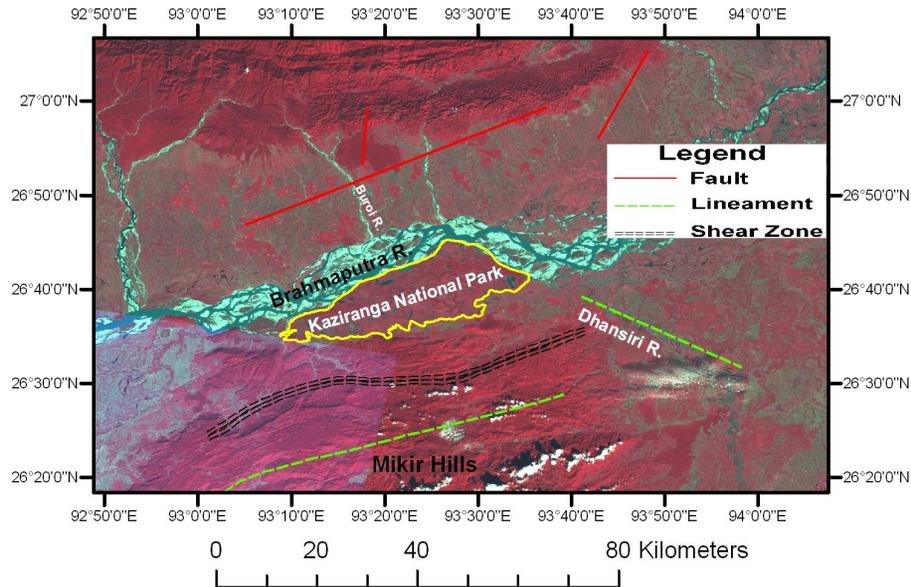
Fig. 4. Showing the major faults and lineaments.

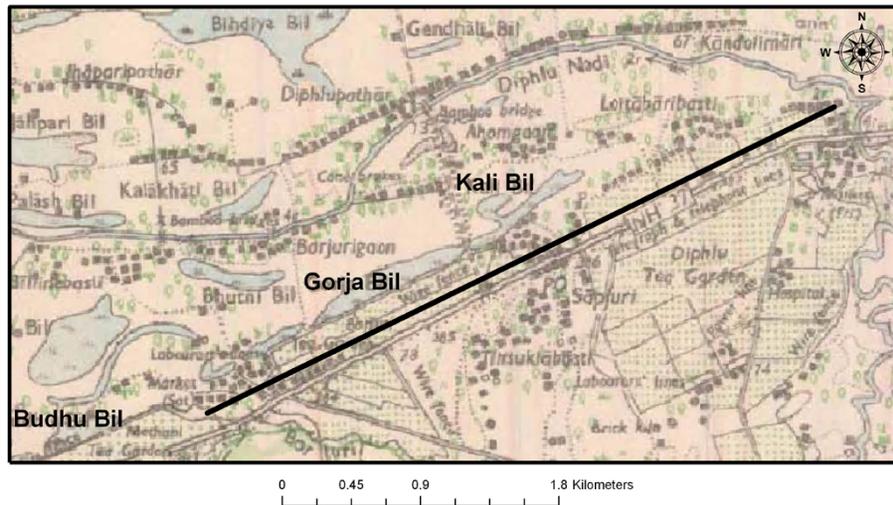
Fig. 5. Neotectonic scarp as shown by a straight scarp shown by Budhu Bil, Gorja Bil and Kali Bil.

Gowd et al. (1998), Molnar (1987), Gahlaut and Chander (1992) attribute the higher seismicity of the Meghalaya-Mikir blocks to reactivation of what has been postulated as a gently dipping shallow thrust or midcrustal detachment. According to Valdiya (1973) many E-W and transverse faults that dissect the block are active. The course of the Brahmaputra changes its trend from ENE-WSW to nearly SE-NW at the confluence of the Dhansiri river on the east of Kaziranga (Fig. 4). Characteristically this trend is lying perfectly along the Dhansiri lineament (Fig. 4). The Dhansiri lineament can be traced along the SE-NW trending lower course of the river Dhansiri, through the segment of the Brahmaputra in same trend east of Kaziranga National Park, up to Himalayan foothills along the course of the river Buroi. The course of the Brahmaputra again changes its trend towards nearly NE-SW on the north of Kaziranga which is parallel to the Himalayan Foothills Thrust (Fig. 4). On the west of Kaziranga the Brahmaputra trends to nearly E-W direction. This had happened due to the influence of a major lineament on the north of Mikir Hills having the same E-W trend (Fig. 4). The influence of the fault in front of the Mikir Hills can be seen along a scarp near Methoni Tea Estate and in some swamps (Budhu Bil, Gorja Bil and Kali Bil) having a perfectly linear southern boundary (Fig. 5).

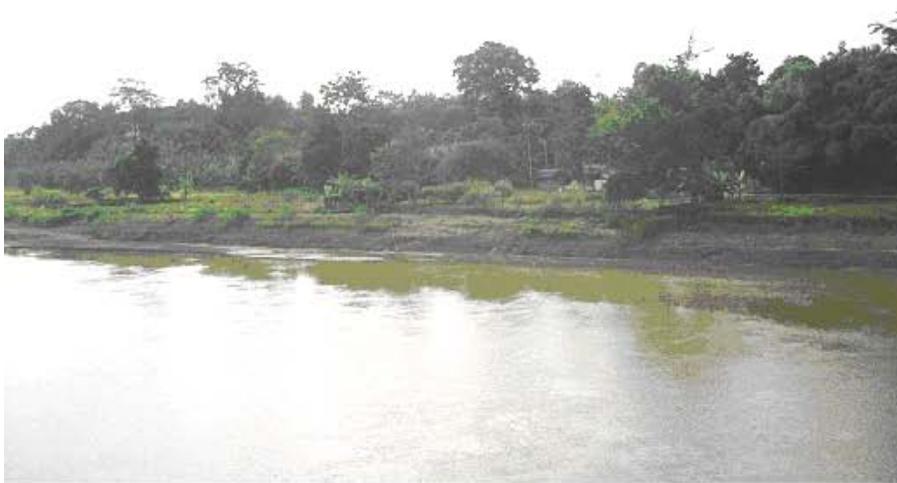
Fig. 6. The neotectonic fault scarp on the left bank of the Dhansiri River.

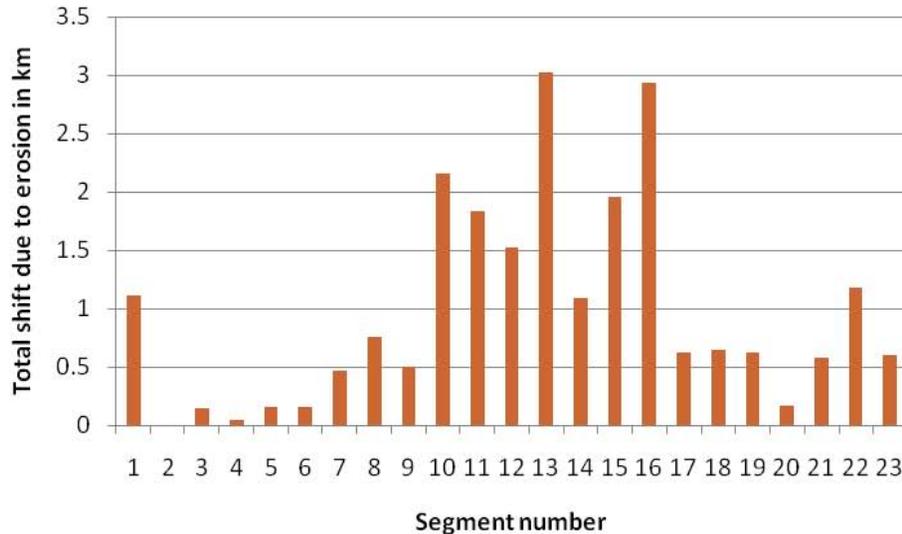
**Fig. 7.** Plot of total shift in km due to erosion against segment number.[Title Page](#)[Abstract](#)[Introduction](#)[Conclusions](#)[References](#)[Tables](#)[Figures](#)[⏪](#)[⏩](#)[◀](#)[▶](#)[Back](#)[Close](#)[Full Screen / Esc](#)[Printer-friendly Version](#)[Interactive Discussion](#)

In order to have an idea about future trend of erosion and deposition in different parts of the park along the river Brahmaputra the data on bankline shift leading to erosion and deposition from 2000 to 2008 have been analyzed. The amount of bankline shift of the river Brahmaputra leading to erosion and fill (deposition) along the Kaziranga National Park from $93^{\circ}00'$ to $93^{\circ}44'$ have been estimated at each $02'$ longitude (east) interval dividing the river course into 23 equal segments of about 3–4 km length. Segment 1 represents $93^{\circ}00'$ – $93^{\circ}02'$ at downstream and segment 23 represents $93^{\circ}42'$ – $93^{\circ}44'$ in upstream according to geographic east longitude. It is observed that frequency of occurrence of bankline shift due to erosion is the maximum at segment nos. from 11 to 15, minimum (nil) at 2 and moderate at segment 7, 16, 21 and 22.

Fig. 7 it also clear that the nature of fill up is just the reverse of the cases of shift due to bank erosion discussed earlier.

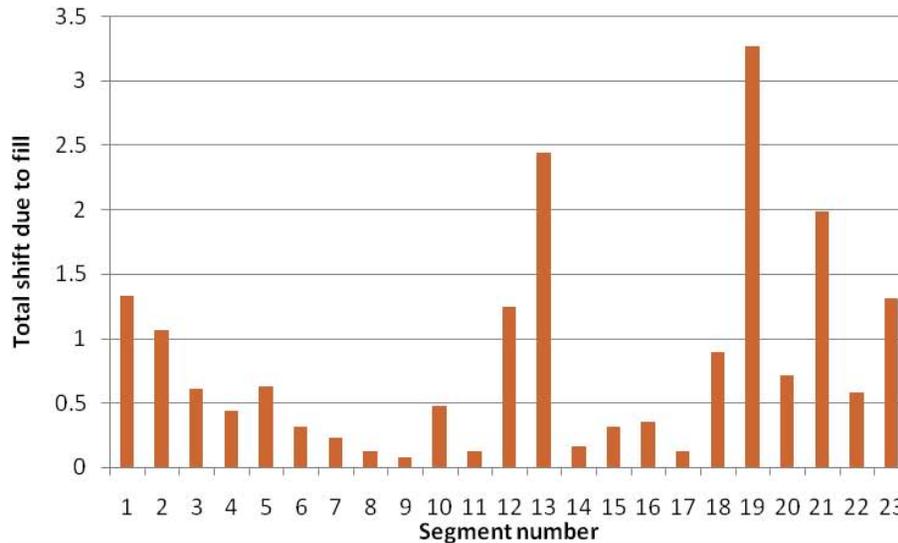
Fig. 8. Plot of total shift in km due to fill (deposition) against segment number.

A plot of total amount of shift due to fill up in km at different segment is shown in Fig. 8. It is evident from the Fig. 8 that relatively greater amount of shifts are confined in segment nos. 12 and 13 ($93^{\circ}22'$ – $93^{\circ}26'$) and 18–23 ($93^{\circ}34'$ – $93^{\circ}46'$). These segments are lying in the middle and upstream part of the Brahmaputra river. Comparing this with

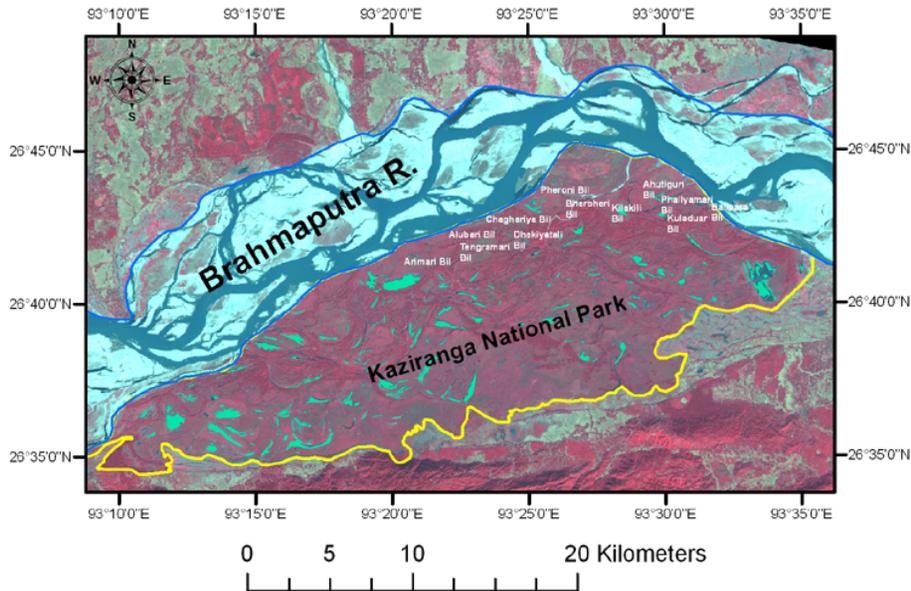
Fig. 9. Geographical location of the areas of future erosion.

In order to have an idea about future trend of erosion and deposition in different segments of the study under study the data on bankline shift leading to erosion and deposition from 2000 to 2008 have been analyzed for the south bank of the river Brahmaputra, i.e. along the northern boundary of Kaziranga national Park. A plot of total amount of shift due to erosion in km at different segment is shown in Fig. 7. It is evident from the Fig. 7 that the greater amount of shifts are confined in between segment 10 ($93^{\circ}18'$ – $93^{\circ}20'$) and 16 ($93^{\circ}30'$ – $93^{\circ}32'$). These segments are lying just at and downstream of the bend of the Brahmaputra River. Hence it can be inferred that in future the erosion may continue to occur in these segments, i.e. from segment 10 ($93^{\circ}18'$ – $93^{\circ}20'$) and 16 ($93^{\circ}30'$ – $93^{\circ}32'$). Geographical location of these areas, from east to west, will be successively Balipara Bil, Phallyamari Bil/Kuladuar Bil, Kilakili Bil/Ahutiguri Bil, Pheroni Bil/Bherbheri Bil, Charghariya/Dhekiyatali Bil, Alubari Bil/Tengramari Bil, and Arimara Khuti within Kaziranga National Park (Fig. 9).
